The stronger the better is not necessarily the case for fasteners

By Bill Eccles, Bolt Science

Originally published in Fastener + Fixing Technology Issue 11, October – December 2013.

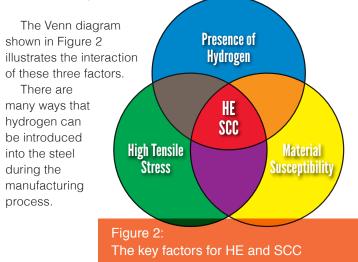
Figure 1: M10 electroplated 12.9 screw cracked under the head the hydrogen enters the steel. Once atomic hydrogen is introduced at the surface of the part, there is a migration of the hydrogen over time to the grain boundaries, flaws and inclusions in the material. The effect of the hydrogen is to cause a reduction in the defect formation energy and a decrease in the inter-atomic bonding energy. Atomic hydrogen can also bind together to form hydrogen gas (H2) whose pressure build-up at a crack tip can also have a deleterious effect. By these mechanisms a normally ductile material can behave in a brittle manner. With the fastener under stress (which usually means once it is tightened), cracks are initiated once the local concentration of hydrogen, at a particular defect, exceeds some critical value.

Hydrogen induced cracking, commonly referred to as hydrogen embrittlement (HE), can occur to high strength steels and certain other metals such as titanium and certain stainless steels. Atomic hydrogen can enter the material during the production process or during its service life (as a result of corrosion or hydrogen in the atmosphere) causing a catastrophic brittle fracture. This occurs at a stress level well below the yield strength of the fastener. Figure

> 1 shows a M10 electroplated 12.9 socket head cap screw cracked under the head due to embrittlement. One of the characteristics of hydrogen embrittlement is that it may only affect a small proportion of a batch of fasteners.

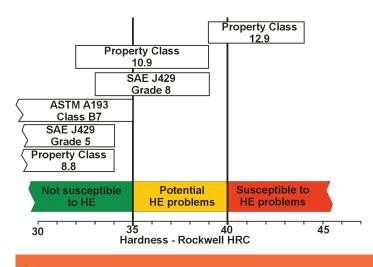
Figure 3: Common bolting materials and their susceptibility to hydrogen embrittlement

Although the alloy content and microstructure has some effect on the susceptibility of steel to hydrogen embrittlement, it has been found that the strength level (hardness) is the key factor. In general, the higher the strength of the steel, the greater is the susceptibility to hydrogen embrittlement. The chart shown in Figure 3 summarises the experience of the susceptibility of common fastener strength grades to HE. As a footnote, in some special circumstances (for example in subsea applications in which cathodic protection is used) fasteners of hardness greater than 34 HRC are susceptible to hydrogen induced brittle fracture.
